Manhole Inspection Summary

Manhole # S11C1_003MH

Insp Date: **4/14/08 9:26 AM**

Location Address: **1401 S Edgewood St**

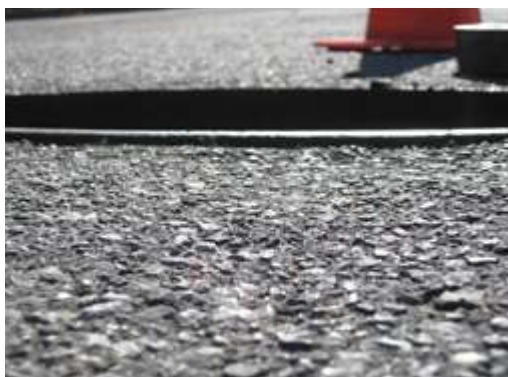
Misc

A/B .5"

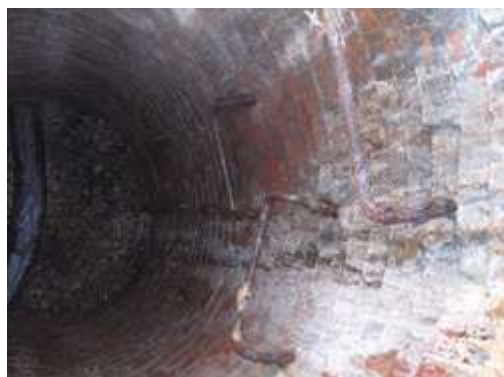
Defect 3

Condition: ☐ Sound ☐ Cracked ☐ Root Intrusion ☒ **Loose Brick** ☐ Deteriorated

Infiltration: ☐ None ☐ Joint ☐ Cracks ☒ **Mortar** ☐ Roots ☐ Wall

Steps Count: **9** Missing: **0** ☒ **Corroded**

Corroded steps, loose bricks and infiltration from chimney

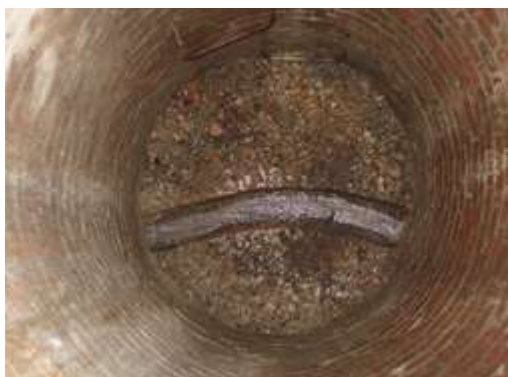
Defect 1

Condition: ☐ Sound ☐ Cracked ☐ Root Intrusion ☐ Deteriorated ☐ Leaks ☒ **Debris**

sediment on bench

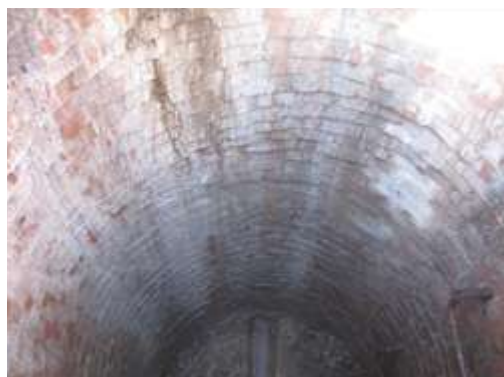
Defect 2

Frame Offset: **0** (in.) Condition: ☐ Sound ☐ Cracked ☒ **Leaks**

infiltration from frame

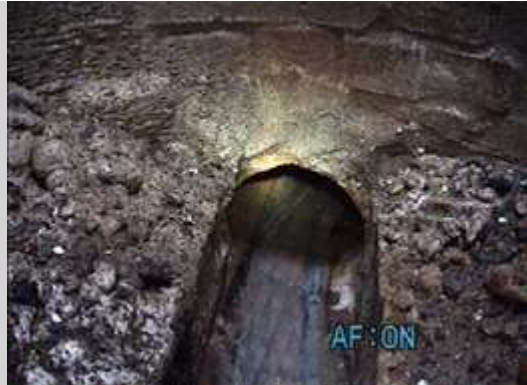
12 O'Clock Outflow

8 in. Circular Gravity Sewer
Pipe Out @ 12 O'Clock

Pipe Height: **7.2** (in.) Rod and Bar (Angled)
Pipe Material: **Clay** ☐ Pipe Lined
Invert Depth: **11.08** (ft.) Flow Characteristics: **Fast**
Deposits: ☒ None ☐ Mud ☐ Sludge ☐ Debris ☐ Grease
Silt Depth: **0** (in.) Deposits Extent:
Infiltration: **None** Pipe Seal Cond: **Sound**

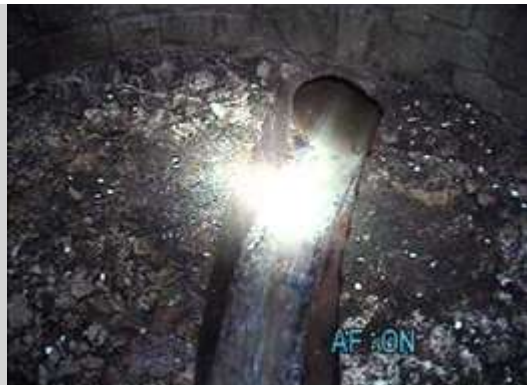
7 O'Clock Inflow

8 in. Circular Gravity Sewer
Pipe In @ 7 O'Clock

Pipe Height: **8.4** (in.) Rod and Bar (Angled)
Pipe Material: **Clay** ☐ Pipe Lined
Invert Depth: **10.87** (ft.) Flow Characteristics: **Fast**
Deposits: ☒ None ☐ Mud ☐ Sludge ☐ Debris ☐ Grease
Silt Depth: **0** (in.) Deposits Extent:
Infiltration: **None** Pipe Seal Cond: **Sound**
